# TWISP MUNICIPAL AIRPORT 2005 PAVEMENT MANAGEMENT REPORT

**February 2006**

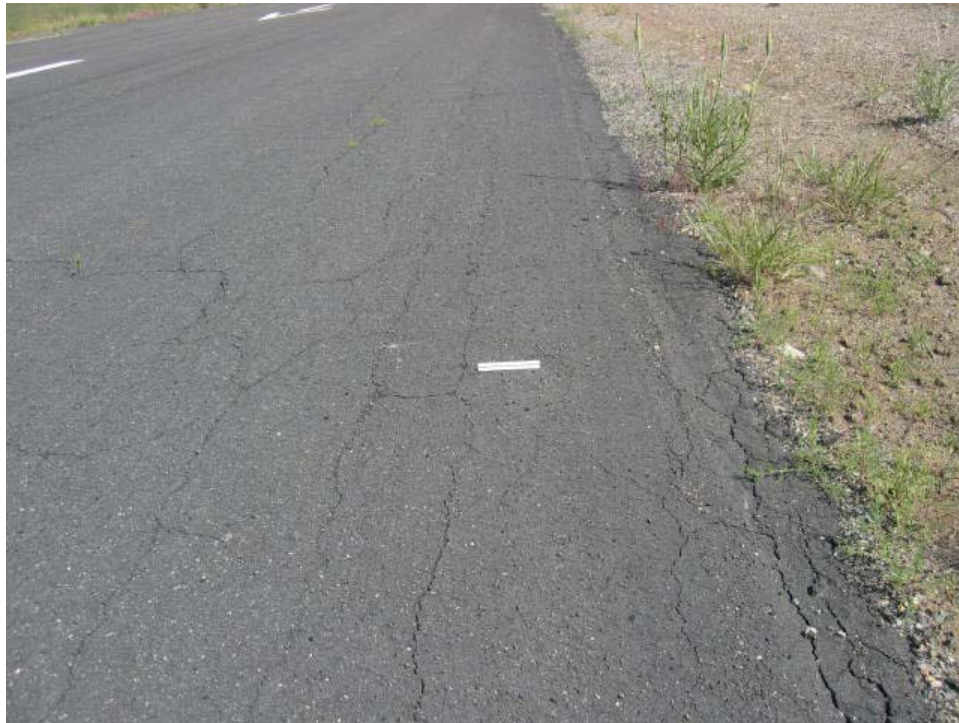
R10TW-01. Alligator cracking.

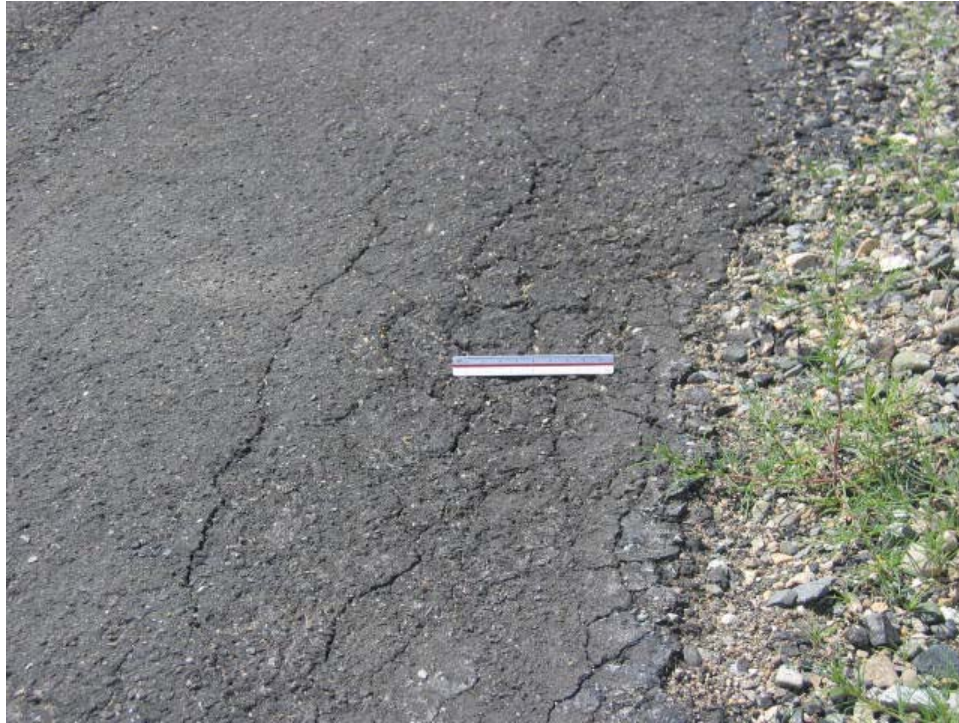
T01TW-02. Alligator cracking (1).

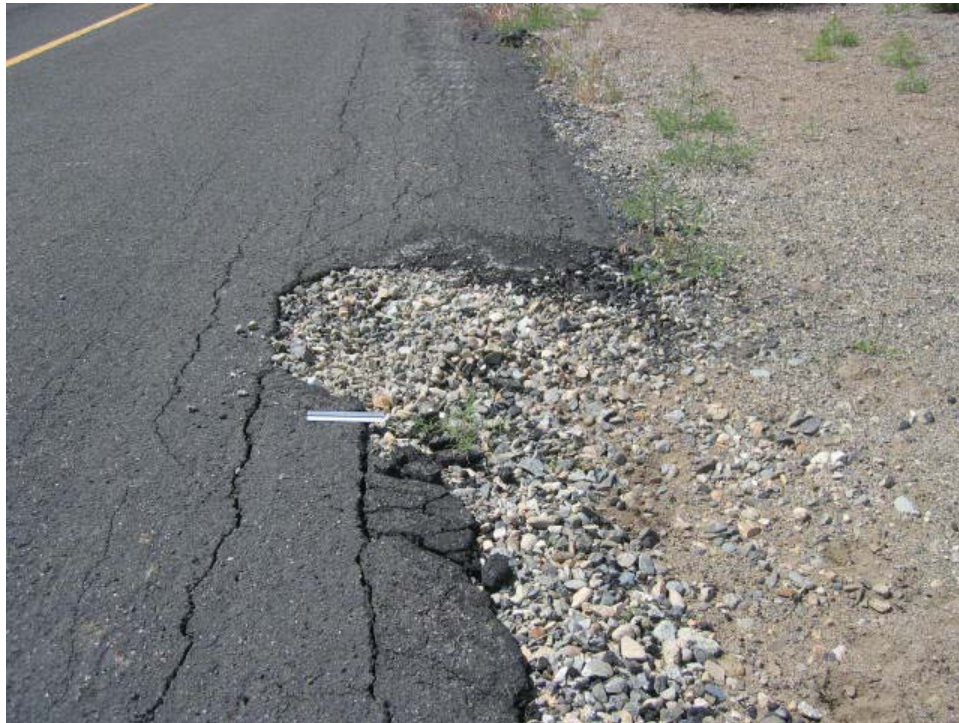
T01TW-02. Alligator cracking (2).
